TP 6980E
(04/2007)

Issue 1/2007

Canadian Aviation Service Difficulty Reports

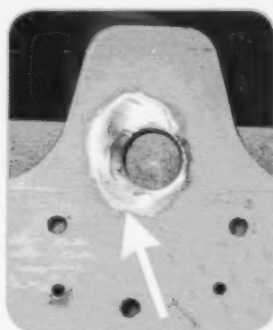
Upon visual inspection and cleaning of attachment lug area of a vertical fin to horizontal stabilizer, the technician noticed material flaking off of one bolthole area. Further inspection revealed exfoliation corrosion. Since this type of corrosion is difficult to detect visually it was only when the technician was cleaning the area that he noticed the damage.

Upon consultation with the manufacturer (Raytheon), the corrosion was removed to determine the extent of penetration and coverage (photo illustration). The penetration and coverage was determined to be out-of-tolerance and required replacement of the reinforcement plate. This was the first time the manufacturer had come across this type of discrepancy.

Especially significant was the fact that it was exfoliation corrosion and not any type of surface corrosion. The task to replace the part was extensive, requiring specialized jigs, tools and machining along with rigging checks. The job was successfully completed by a qualified service center.

Corroded (exfoliation) area blended out - Out-of-Tolerance

Transport Canada recommends that operators and maintenance organization be cognizant of the manufacturer's Corrosion Prevention and Control Program (CPCP) and aging aircraft initiatives. ✖

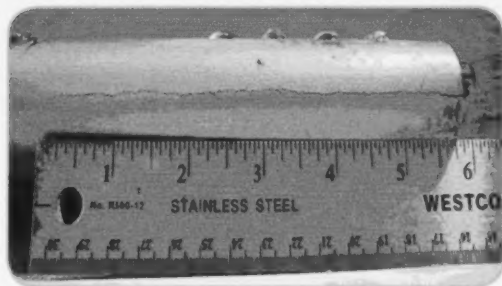
During 100-hour inspection of a DHC 2 (Beaver), six (6) inch stress cracks were found to have originated at the top forward side of the struts on the right and left rear float struts.

Time-in-service is unknown and total aircraft time is over 22,000 hours. The aircraft is operated exclusively on floats in a corrosive environment and generally adverse landing conditions.

Most of these legacy aircraft have seen many hours of operation in a corrosive environment and rough water landings are common. The deterioration of aircraft structural elements can be greatly accelerated by the environment and undesirable landing conditions. Special attention to these legacy aircraft will keep them structurally sound and safely flying for many more years. ✖

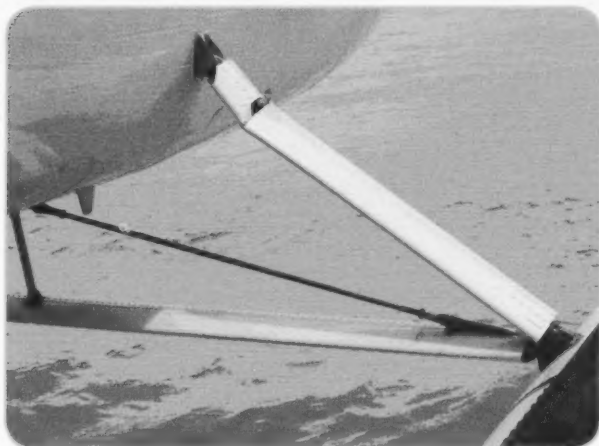
A foreign operator of a DHC-6 Twin Otter reported to the aircraft manufacturer that he landed in high waves and broke both front float struts. The aircraft taxied to the dock without incident.

A maintenance technician inspected the aircraft for other damage caused by landing in such rough water. No other damage was evident. Both front float struts were replaced and the aircraft returned to service.

Transport Canada recommends following the manufacturers' recommended operational procedures and inspection criteria.

When operations require you to utilize the aircraft in extreme conditions, preventive maintenance and additional inspections may have to be considered. ✖

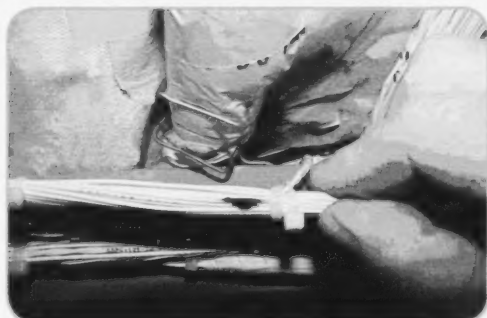
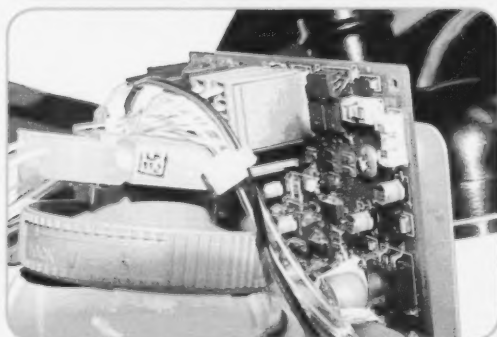
Investigation into the cause of the circuit board damage revealed that the wire on the outlet side of all of the PSU control circuit boards had chafed through the outer insulation resulting in a short circuit to ground at STN X312.35. This short circuit resulted in the outlet transistor to burn out on all PSU control circuit boards.

It is to be noted that since the aircraft was brought into service, the area of the wire chafe had not been inspected nor was it a requirement. The damaged wire was able to contact a trim support clip because the wiring bundle was incorrectly placed outside of the cable trough.

The aircraft manufacturer has indicated that an investigation into this incident was conducted. It has been determined that the wiring bundle should have been in the wire trough provided. Also, as per the drawings, no insulation clip is located in this area.

STN X312.35 - Wire 3322AP
- Cable trough - Insulation retainer Clip

All aircraft cabin PSU's were replaced and the aircraft returned to operational service.

The manufacturer is considering the addition of a fuse to prevent damage to the PSU if an electrical short in the wiring installation were to occur. ✱

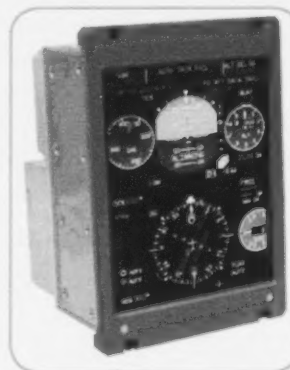
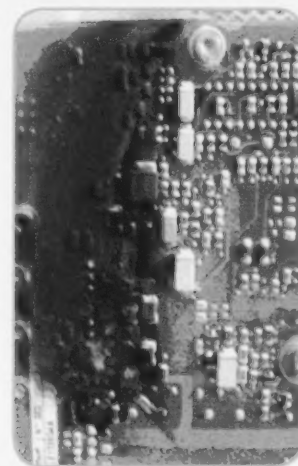
Following this incident a burning odor with no visible smoke or flames was detected. The odor was carried throughout the cabin by the re-circulation fan and detected by the flight attendants. Mechanics found evidence of soot around the cooling holes of the removed PFD.

The part was returned to the PFD manufacturer for investigation. The manufacturer reported a strong burnt smell before disassembly. When the power was turned on to the PFD unit there was high smoke emission. The root cause analysis was the short circuit on C43. This type of ceramic capacitor (C43) is no longer used on power supply module (PSM) boards.

This SB is applicable to the Thales Avionics SMART MULTI-FUNCTION DISPLAY 6X8 (SMD68) PNR C19190AB04. The SB indicates that for each display with Serial Number below 892 equipped with PSM board Serial Number below 1531, it is recommend to exchange the PSM board by a new one with a Serial Number above 1531 (1531 included). ✱

Thales Avionics (manufacturer) issued a service bulletin (SB) C19190A-31-014 to inform operators of the introduction of a new technology of capacitors in the PSM board in order to prevent capacitors from breaking and causing short circuits.

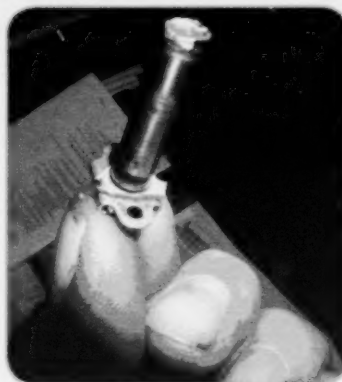
While performing an aircraft walk around, there was excessive play found at the rudder upper attachment bolt.

Further investigation discovered the upper attachment bolt had elongated the hole and also damaged the nose rib. When trying to remove the bolt, the nut plate broke away and a piece of the nose rib that was already cracked actually broke away with the nut plate. The bolt head had to be cut off to remove the rudder and the upper bearing was found damaged. The damaged rudder is now awaiting parts to facilitate a repair.

Maintainers are reminded that movement of flight controls while performing daily checks can detect latent failures. Had this defect gone undetected, serious rudder control restrictions could have been experienced. ✖

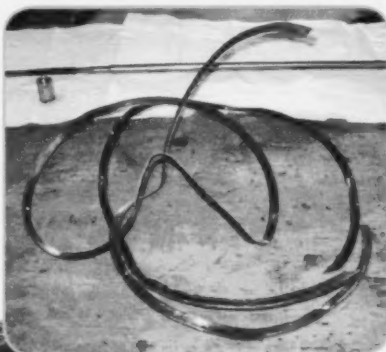
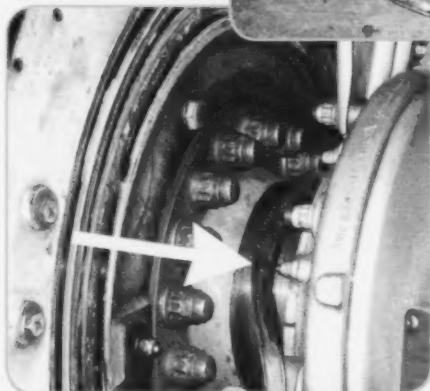
Slip Rings

Upon further investigation, maintenance personnel found that all three of the propeller brush block slip rings had separated from the propeller bulkhead and then wrapped around the propeller shaft.

The propeller bulkhead has been sent out for repair and a strip report. ✖

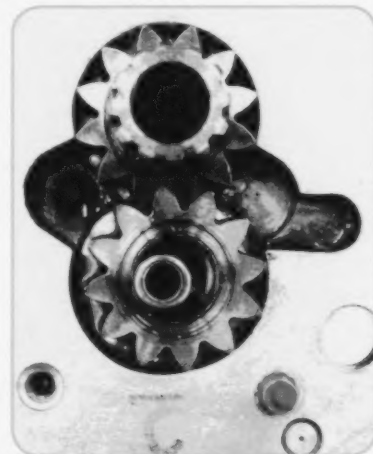
The engine was submitted for its scheduled first time overhaul. When the propeller governor 1584 hours time since new (TSN) was dismantled for cleaning before overall inspection, it was discovered that the idler gear bushing, P/N 5337050, was severely worn. The excessive bushing wear resulted in an elliptical rotation of the idler gear, which caused the gear pocket to wear in an oval manner on the pressure side.

A normal idler gear bushing measures approximately 0.100", however this worn idler gear bushing measured 0.0175". It is not known what caused this excessive bushing wear.

The periodic oil analysis did not detect any metal contamination. After discovering this condition, the maintainers were unable to rotate the

gears manually and found that the gears would stick and bind. This raised concerns that if this occurred in service, then seizure and complete loss of propeller governor oil pressure (loss of thrust) was possible.

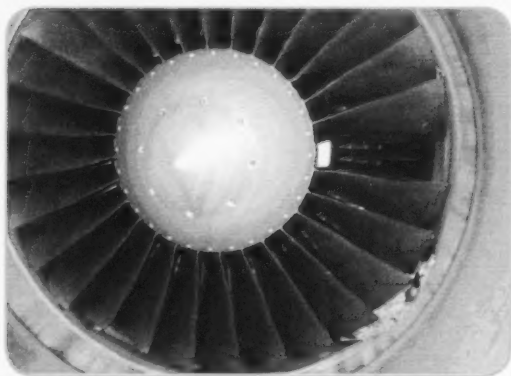
Maintenance personnel reported that one of the fan blades was missing and that the jet pipe appeared burnt and cracked.

The General Electric field service representative observed that one fan blade and the outboard fan cowling was missing. Two (2) small punctures were noted in the fan containment case as well as damage to the bolts that connect the LP Turbine and HP Turbine flanges. Fire damage to the exhaust nozzle was evident.

Shortly after this event, the engine manufacturer issued an All Operator's Wire CF34-06-07 related to this event. Investigation is ongoing at this time to determine the cause of failure of the #11 fan blade. ✖

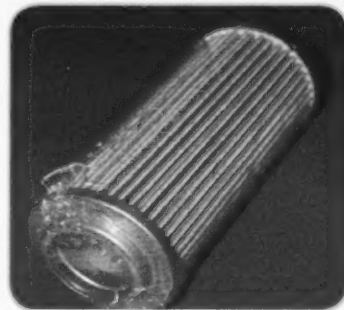
The engine-driven fuel pump filter was replaced with a new PMA filter which was pre-packaged in plastic wrap. This particular PMA filter has an opening at one end and is sealed at the other end. The installer used his finger to remove the plastic wrapping, however a piece of plastic inadvertently got pushed up inside the fuel filter.

The SDR submitter stated that the Purolator airframe fuel filters are also wrapped in this fashion. The main difference is that the airframe fuel filter is open at both ends allowing pieces of plastic to fall through it. Maintainers must be aware of this problem and ensure that filters are free of contaminants prior to installation.

Transport Canada Civil Aviation concurs with the SDR submitter's recommendation that maintainers ensure that filters are clear of contaminants. Always double-check before installing parts. ✖

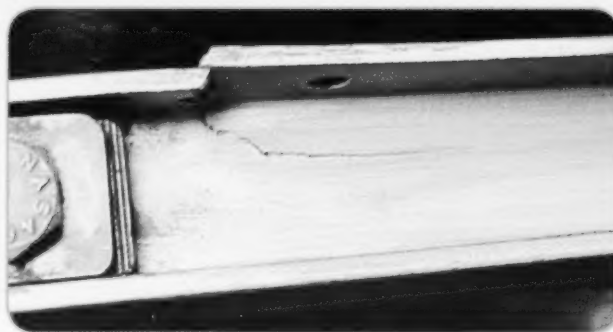
While carrying out an inspection on the engine thrust reverser system, the AME visually detected a significant crack on the LH lower thrust reverser track.

The cause of the thrust reverser crack is likely due to time in service. ✖
